Structural Report

June 12, 20XX

345 Any Street

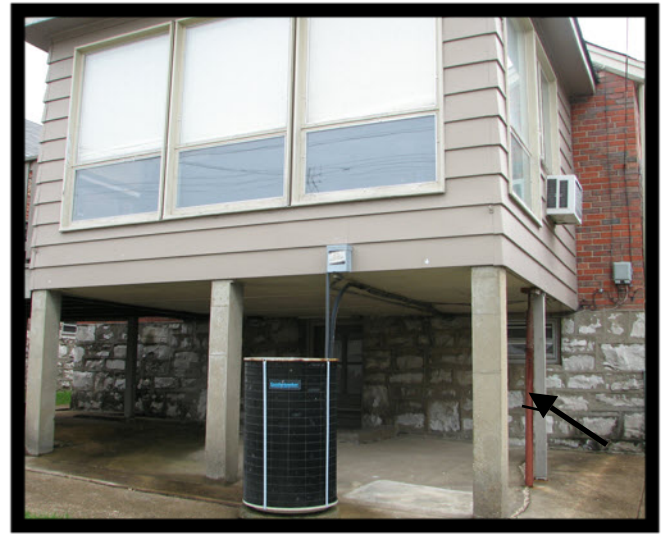
Figure 1

A structural inspection was made of 345 Any Street on June 12, 20XX. The weather was mild and overcast. To avoid the possibility of damage to the present owner's property, the extent of this inspection was necessarily limited to the visible portions of the structure and accessible components. The purpose of the inspection was to evaluate the settlement and general structural integrity of the sunroom at the rear of the structure (Figure 1).

The room appears to have been built on top of a structure that was originally a deck. The floor consist of 2" x 8" joist on 16" centers running parallel to the rear of the house. The room is approximately 14 1/2 feet wide and extends 12 feet from the rear of the house. The extension is supported with three concrete pillars 7 1/2 inches square 6 1/2 feet apart. Two temporary columns have been placed at the mid point on one side as shown in Figure 1. The ends of the joist appear to be supported by nails only in a double 2" x 8" beam on each end. It could not be determined fully how the structure is secured the the main house structure. The house structure walls are solid brick. Inspection of the interior of the sunroom reveal a gap between the sunroom wall and the rear of the house approximately 3/8 inch as seen in Figure 2.

The structure as it stands is not structurally adequate. It is recommended that the plywood be removed from the under side of the floor joists. The wooden structural components be inspected to insure that no water intrusion has deteriorated any of the structural components. It is then recommended that the floor section be properly anchored with bolts passing through the brick wall and into the wood floor structure of the house. It is also recommended that 2" x 8" floor joists be added between each of the current 2" x 8" joist. The current span is too much to be carried by 2" x 8" on 16" centers. Each end of the new joists as well as the old joists should be supported with proper joist hangers. A second support column should be added at the mid point of each of the double 2" x 8" beams on each end of the floor structure. These should be supported by concrete piers extending at least 30" into the ground. Additionally proper flashing should be installed in the area where the roof line meets the rear wall.

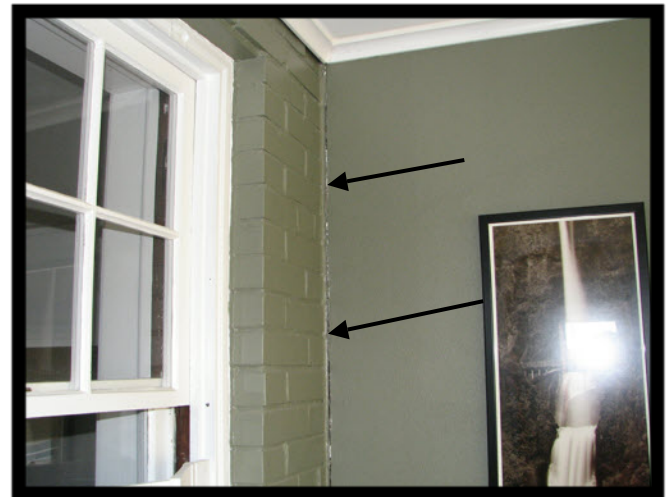
Figure 2

The owner stated that they had recently noticed the gap in the wall changing as well as water had started leaking between the room ceiling and the main house. They also stated that they had just recently repaired the french drain from the rear east corner downspout. The water from this downspout had been leaking into the basement area. The french drain runs partially under the concrete under the room.

It is this writers opinion that the recent settlement activity was most likely caused by the malfunction of the french drain directing water under the support area of the beams. The current concrete beams show no signs of significant movement and are indeed vertical when measured with a level. It is recommended that after the structure has been reinforced, the gap be sealed and monitored for any future movement. If further movement is detected then some type of pier system may have to be installed at that time.

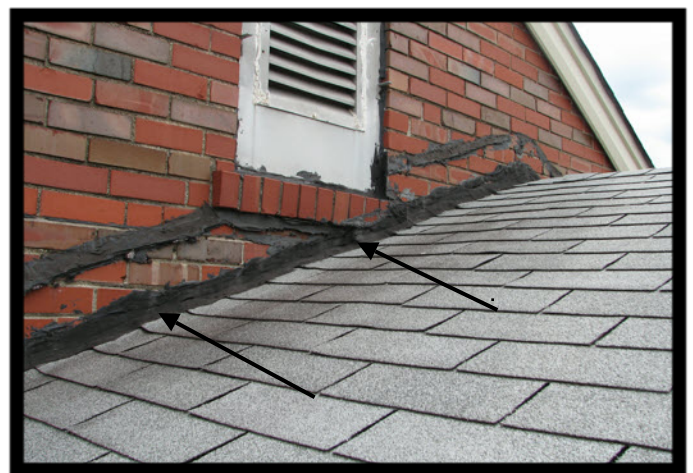
Figure 3

Inspection of the roof area revealed there was no flashing between the wall and the roof over the sun room as shown in Figure 3.
