BUILDING INSPECTION REPORT

Any Home Buyer
1234 Main Street

Harry O. Morrell
Allied Building Inspections
314-223-7310

FILE #:	13-0101A.
DATE OF INSPECTION:	January 1, 2014.
TIME OF INSPECTION:	9am.
END TIME OF INSPECTION	12 Noon.
CLIENT NAME:	John Smith.
MAILING ADDRESS:	1234 Elm Street.
CLIENT CITY/STATE/ZIP:	St. Louis, MO 123456.
CLIENT PHONE #:	314.222.1111.
Client Email Address:	john@homebuyer.com .
CLIENT FAX #:	314.111.3333.
INSPECTION SITE:	1234 Main Street.
INSPECTION SITE CITY/STATE/ZIP:	St. Louis, MO 63100.
INSPECTION SITE PHONE #:	314.444.5555.

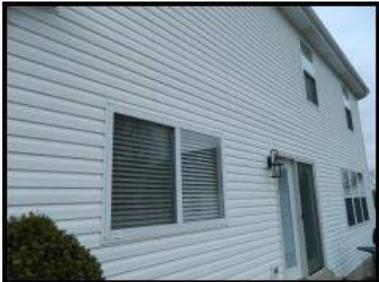
Vinyl siding.
The cladding/siding components are performing as intended without signs of significant damage or defects, The photo shows typical condition of the exterior cladding at the time of inspection.

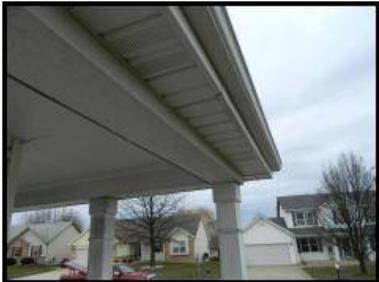
Wood, Metal, Vinyl.
The wood/metal trim components are performing as intended without signs of significant damage or defects, The photo shows typical condition of the exterior trim at the time of inspection.

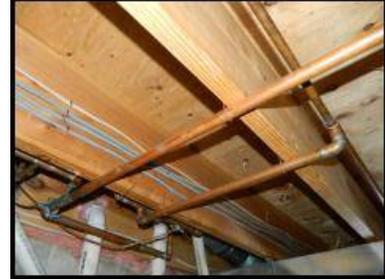
FLOOR STRUCTURE	The floor structure is standard wood joists and plywood subfloor supported on the exterior foundation walls with steel columns and posts. Visible areas of the floor framing system are in good condition and performing as intended. Photo shows typical condition of the floor joists at the time of inspection.

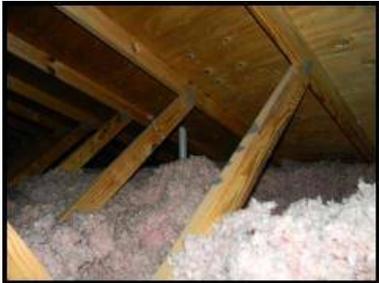
ACCESSIBILITY AND CONDITION:	Attic is full size, Truss framing, No walk boards are provided, Ventilation is provided.
INSULATION TYPE AND CONDITION:	Fiberglass- Blown, Ventilation is present and provided at, Gable ends, Soffit vents, The attic is well ventilated. This will extend the service life on the roofing if all other conditions are performing as intended as well. Photo shows insulation and roof structure performing as intended.
DEPTH AND R-FACTOR:	8-9 inches, This attic is well insulated.

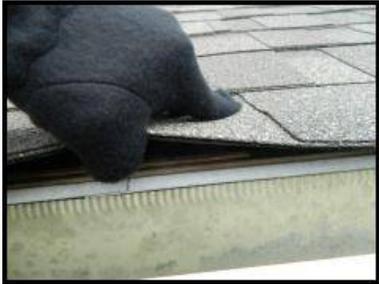
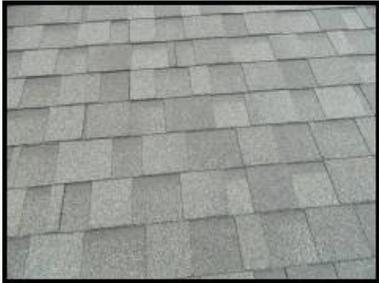
STYLE:	Gable.
TYPE:	Laminated or dimensional grade asphalt composition roofing, Photo shows evidence of single layer present.
ROOF ACCESS:	Walked on roof, The roof was inspected from the attic as well, for water stains or leaks.
ROOF COVERING STATUS:	The roofing appeared to be a professional installation and was performing as intended without any evidence of damaged, loose, or missing shingles. All roof penetrations were properly flashed with metal. No evidence of leaks or water penetration was observed when inspecting from the attic as well. It is likely that this roofing will reach its average service life if normal weather conditions prevail. Photo shows asphalt shingle roofing aligned properly with no defects, which was typical for both sides of the slope.

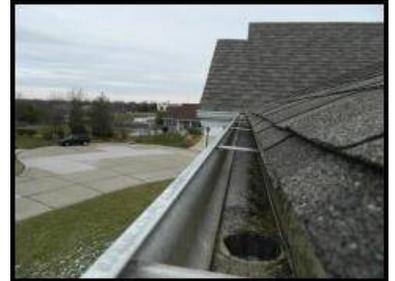
TYPE & CONDITION: Full, The gutters were installed properly, free of debris and/or standing water, and were performing as intended without signs of damage or deterioration. Photo shows gutter free of debris and/or water and performing as intended.

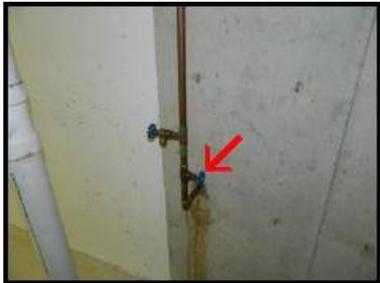
MATERIAL:	Copper.
CONDITION:	Water meter is located at front exterior, Valve not tested, Main line is 3/4 inch diameter, Water pressure appears adequate, The main water shut off is located at the basement front wall. See photo.

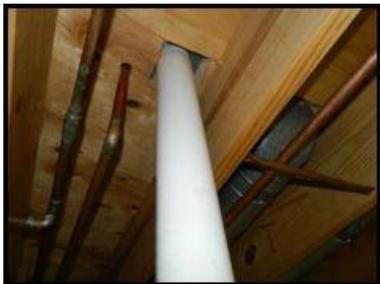
MATERIAL:	Plastic.
CONDITION:	Visible portions of the waste lines were performing as intended without significant signs of damage or defects, or any type of leakage. Photo shows main stack in basement performing during full load operational test without leakage.

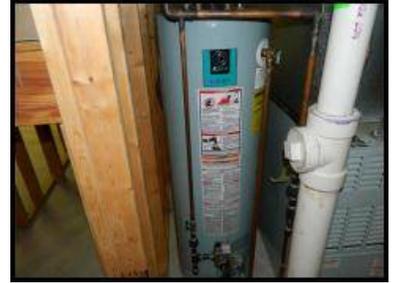
Pressure relief valve noted, not tested, Flue vent intact, A water shutoff valve is installed, The water heater was in operation at the time of inspection. No significant defects or damage was observed. Hot water was present at the fixtures that were tested. The photo shows the typical condition of the water heater at the time of inspection.

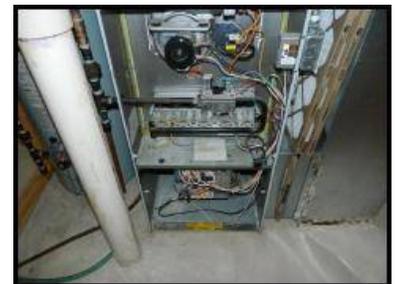
PRIMARY UNIT:	The unit was operational and performing as intended at the time of inspection. The photo shows the furnace with the panel covers off for inspection purposes only.
BURNERS/HEAT EXCHANGERS:	Burner Flame(s) appear typical.
PUMP/BLOWER FAN:	Ran smooth at the time of inspection.

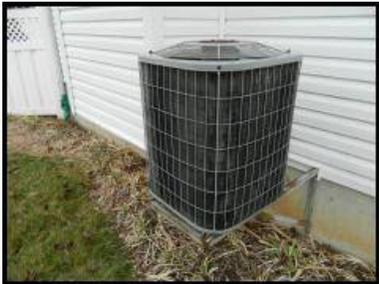
TYPE:	Central, Electric.
POWER SOURCE:	240-volt, Electrical disconnect present.
COMPRESSOR AGE IN YEARS:	Original.
CAPACITY OF UNIT:	3-ton.
RETURN AIR TEMPERATURE:	72.
SUPPLY AIR TEMPERATURE:	52.
AIR TEMPERATURE DROP:	20.
SYSTEM CONDITION:	The AC unit was in operation at the time of inspection and was performing as intended without signs of significant defects or damage. The photo shows the exterior AC unit performing without defects or damage at the time of inspection.
CONDENSATE LINE:	Condensate line installed.
NORMAL CONTROLS:	Operated at the time of inspection and performed as intended.
SECONDARY AIR CONDITIONING SYSTEM CONDITION:	None present at this location.
ADDITIONAL AIR CONDITIONING SYSTEMS CONDITION:	None present at this location.

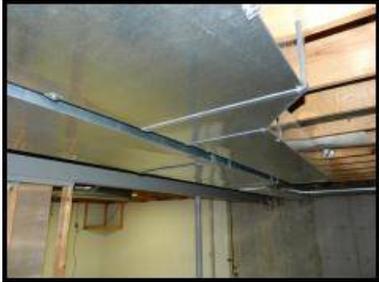
TYPE:	Sheet metal, same as heat.
DUCTS/AIR SUPPLY:	The visible portions of the ductwork for the HVAC system was performing as intended without signs of significant damage or deterioration. The photo shows general condition of ductwork at the time of inspection.
SECONDARY SYSTEM DUCTWORK:	None present or needed for this service.

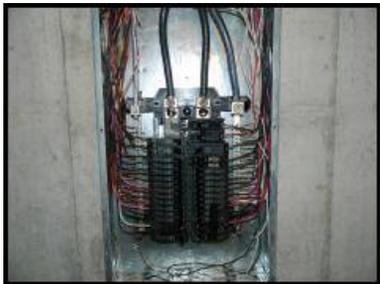
MAIN PANEL LOCATION AND NOTES:	Basement, Photo shows main service panel performing as intended. The panel cover is off for inspection purposes only.
Inspector Notes:	Circuit and wire sizing correct so far as visible, Grounding system is present, A main disconnect was present and installed properly, The circuits were labeled properly.
# OF 120 VOLT CIRCUITS:	8
# OF 240 VOLT CIRCUITS:	4
SUBPANEL #1 LOCATION:	1
SUB PANEL NOTES:	Circuit and wire sizing correct so far as visible, Grounding system is present.

ENTRANCE CABLES:	Aluminum- OK, Recommend non-oxidant paste for aluminum conductors at the lug to prevent excess oxidation deposits at the connections.
BRANCH WIRING:	Copper, Visible portions of the branch wiring performed as intended without signs of damaged conductors or improper wiring. The inspection included placing a load on the entire system.

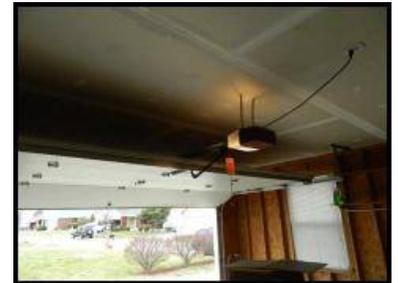
CONDITION: The garage door is metal, The garage door was performing as intended without signs of defects or damage at the time of inspection, Automatic door opener(s)- operational, Automatic reverse feature is, operational. See photo.

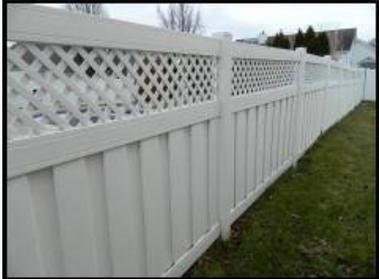
TYPE:	Plastic/PVC.
CONDITION:	Exterior components of the gates and fencing were inspected and tested and performed as intended. The photo shows general condition of the fencing at the time of inspection.
