BUILDING INSPECTION REPORT

Any Home Buyer
1234 Main Street

Harry O. Morrell
Allied Building Inspections
314-223-7310

FILE #:	13-0101A.
DATE OF INSPECTION:	January 1, 2014.
TIME OF INSPECTION:	9am.
END TIME OF INSPECTION	12 Noon.
CLIENT NAME:	John Smith.
MAILING ADDRESS:	1234 Elm Street.
CLIENT CITY/STATE/ZIP:	St. Louis, MO 123456.
CLIENT PHONE #:	314.222.1111.
Client Email Address:	john@homebuyer.com .
CLIENT FAX #:	314.111.3333.
INSPECTION SITE:	1234 Main Street.
INSPECTION SITE CITY/STATE/ZIP:	St. Louis, MO 63100.
INSPECTION SITE PHONE #:	314.444.5555.

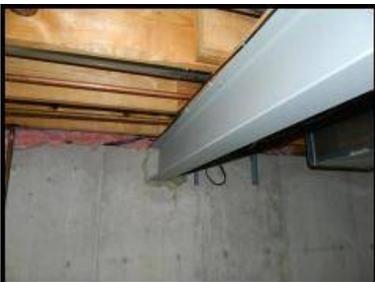
BASEMENT WALLS - TYPE:	Poured concrete.

CONDITION:	The components of the foundation walls are performing as intended without signs of significant damage or defects at the time of inspection, The photo shows typical condition of the foundation walls at the time of inspection.

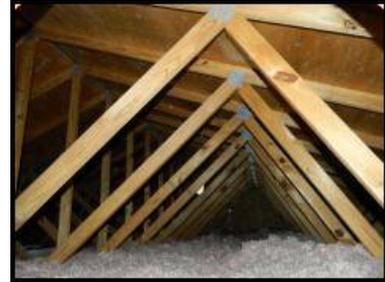
A photograph showing the interior of a crawlspace or basement. It displays wooden floor joists running parallel to each other, with a plywood subflooring on top. Some steel support columns and posts are visible, supporting the structure above.
WALL STRUCTURE	The exterior bearing walls are frame construction. The overall wood frame structure appears to be holding its shape well at the time of inspection. They are performing as intended without any signs of damage or significant structural movement.	
ROOF STRUCTURE	Roof framing consists of standard wood trusses that are performing as intended without any signs of damage or distortions. Photo shows roof structure performing as intended, which was typical from end to end.
